U. S. Department of Agriculture  
Forest Service — Alaska Region  
November 1982

# CARPENTER ANTS: INSECT PESTS OF WOOD PRODUCTS

by Edward H. Holsten

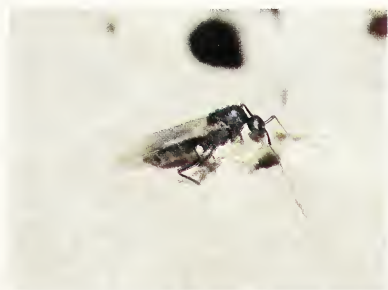
*Figure 1. Winged adult carpenter ant.*

**LIFE HISTORY:** A young colony contains only wingless forms. After the colony has grown to considerable size, a number of winged individuals are produced (Figure 1). These are new males and females (swarmers) whose functions are to begin new colonies. They are commonly seen flying in May and June. After this mating flight, females either reestablish an old colony or establish a new nest. Normally, nests are constructed in dead portions of standing trees, stumps or logs. However, they also nest in structural timbers if they find the conditions suitable. During the first year colonies remain small, consisting of queen, 10 to 20 workers and a few young. In succeeding years, colonies expand rapidly and may number more than 2,000 individuals. It is at this stage that swarmers are produced each year.

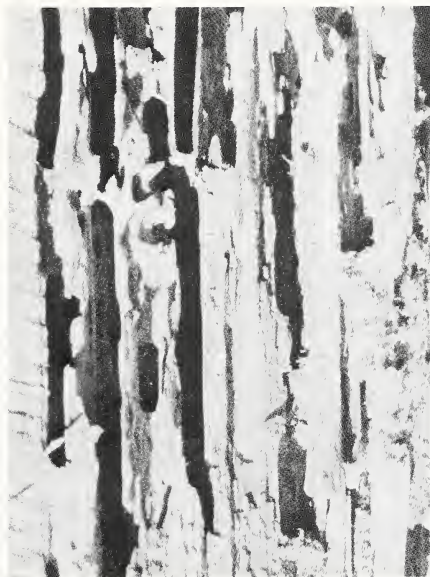
**DAMAGE:** Damaged wood is discovered when its surface is broken open (Figure 2). The only external evidence of attack is the small, inconspicuous cracks and slit-like openings made in the surface by the ants. The galleries extend both along the grain of the wood and around the annual rings. Gallery surfaces are smooth and clean; frass is completely removed except for occasional deposits in unused galleries.

*Figure 2. Advanced carpenter ant damage.*

All kinds of houses, from the newest to the oldest, located in rural areas or cities, become infested. In cities, the ants usually infest houses in wooded areas, but are sometimes found in crowded residential districts as well. Carpenter ants show some preference for moist, rotting wood around the foundations. Once a nest is established, the workers will extend the galleries into sound wood that is adjacent to the partially decayed portion.

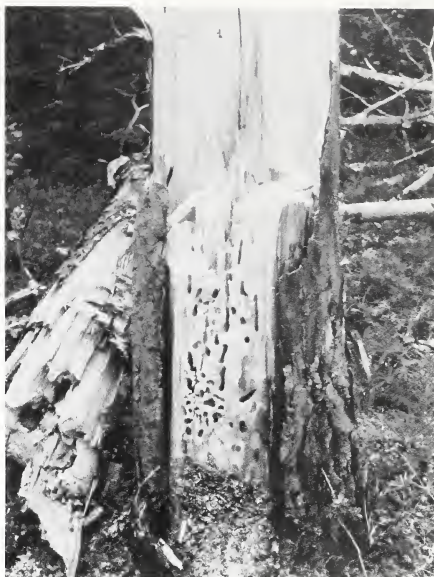
*Figure 3. Carpenter ant nest in a white spruce stump.*

**PRECAUTIONARY MEASURES:** Prevention is the best control. Moist wood is attractive to carpenter ants, so measures that prevent structural timbers from becoming wet are very important. Building sites and adjacent areas should be cleared of stumps and partially decomposed logs (Figure 3). If possible, buildings should be placed on concrete or masonry foundations or on treated timbers. This will reduce carpenter ant attack. Lumber and debris in basements and crawl spaces are attractive to ants and may provide nesting sites. Food, both human and animal, should be protected against insects.

Outdoor nests in stumps, trees and other locations may be treated either by a contact insecticide or by drilling a hole and pouring a liberal amount of kerosene or fuel oil into the nest area. **THESE ARE FLAMMABLE SUBSTANCES; USE EXTREME CAUTION!!**
